Forensic Architect's Investigation of Golf Course Safety

by Michael S. Johnstone, AIA (NAFE 361C)

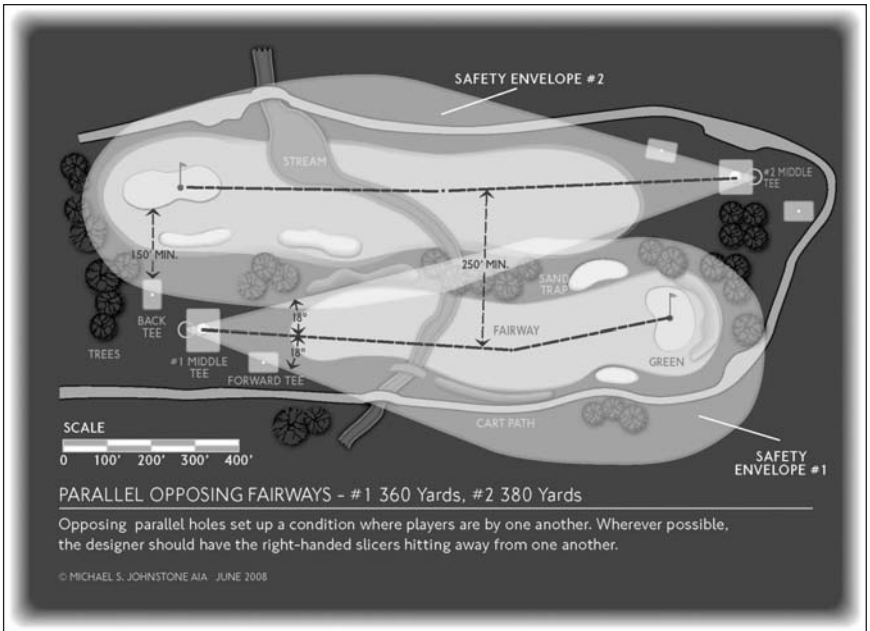
Figure #3.

Parallel Opposing Fairways present an unusual challenge with golfers hitting on parallel lines in opposing directions. If possible, the directions selected should take advantage of the tendency for right handed golfers to slice away from one another, as depicted above. The distance between the two fairway centerlines, should be at least 250 feet. Additional buffers such as trees, shrubbery, earth mounding, screening and deep rough can also contribute to safer conditions.

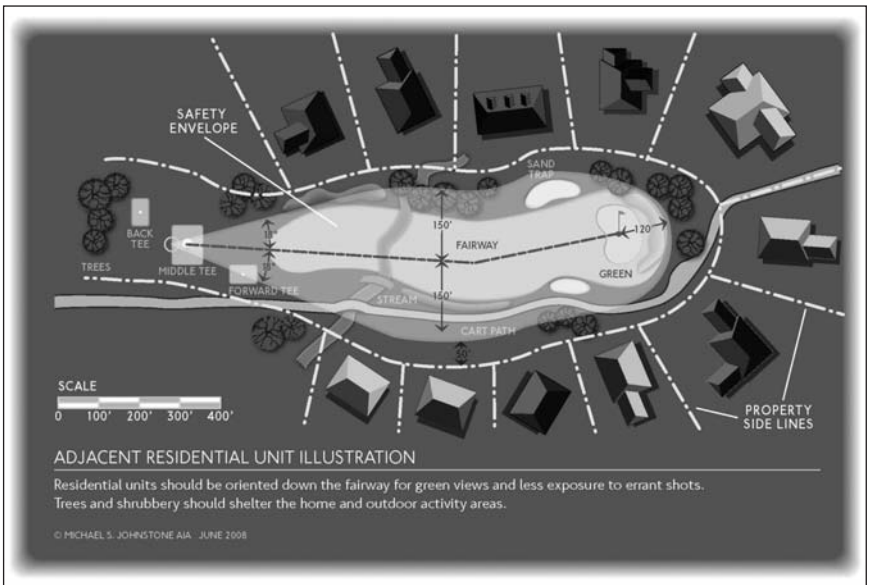
Figure #4.

In residential golf communities, the adjacency of the golf course and residences and backyards creates the potential for personal injury and property damage. After applying the Safety Envelope test, the shared property should be set outside of the Safety Envelope and take into consideration the topography, vegetation, prevailing winds and fairway layout. At this point the Covenants, Conditions and Restrictions of the residential development should describe an additional setback for the home and amenities such as swimming pools and out buildings to further protect residential property and maintain the residence views. Homes should be oriented to face down the fairway to reduce the amount of glass exposed to incoming errant shots.

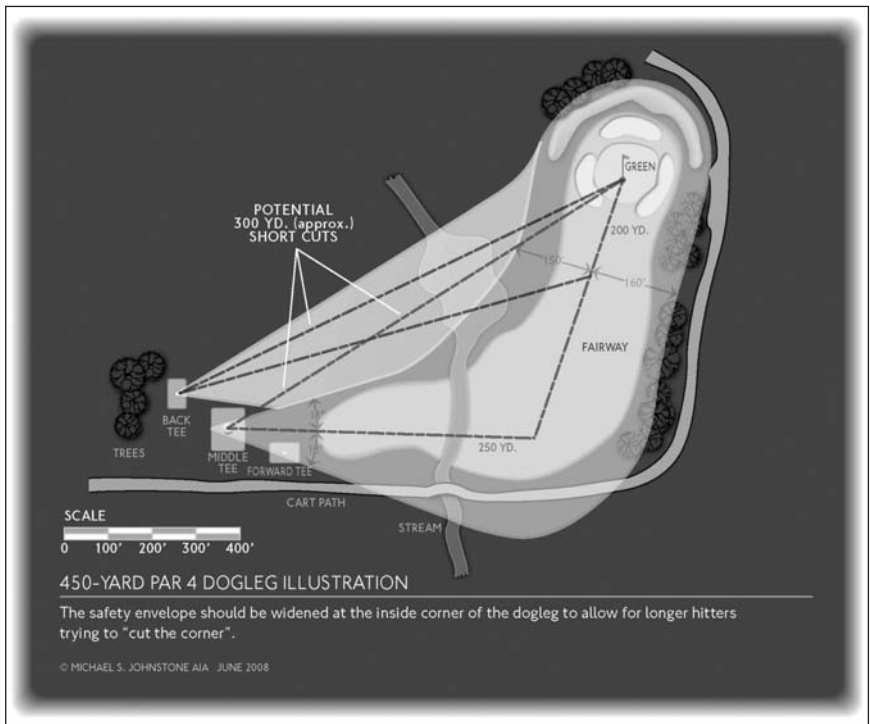
Figure #5.

A sharp “Dogleg” fairway creates an invitation to longer hitters to cut the corner of the Dogleg in order to shorten the hole. Residences, commercial structures and adjacent fairways should not be placed in the inside corner zone.

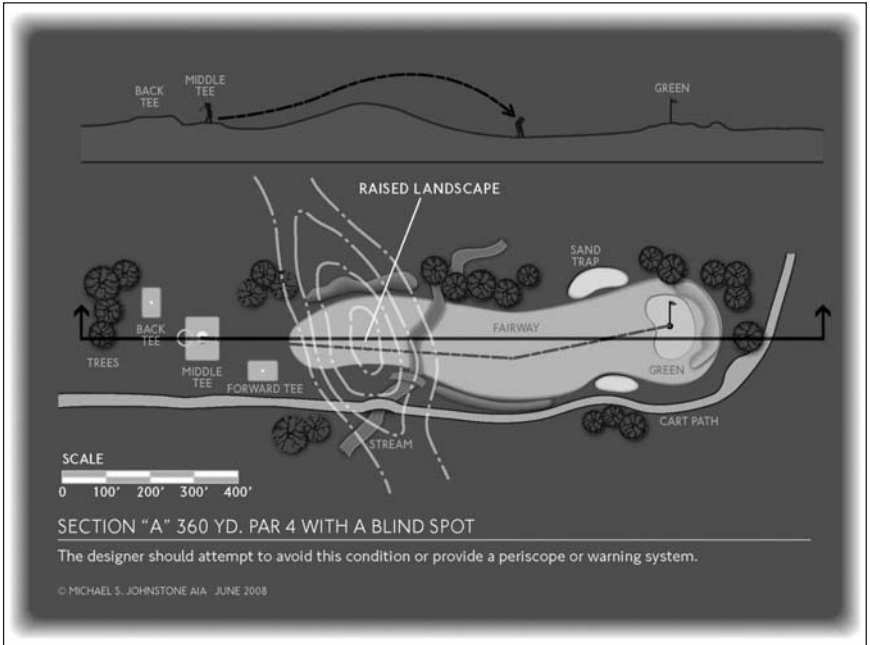
Figure #6.

Topography can create a circumstance where the golfer teeing off may be blind to other players ahead. If this can be avoided by new contouring the safety problem can be avoided. Otherwise course policy should warn the player on the tee or at least provide a periscope so that the player can check to see if the fairway is clear before teeing off.

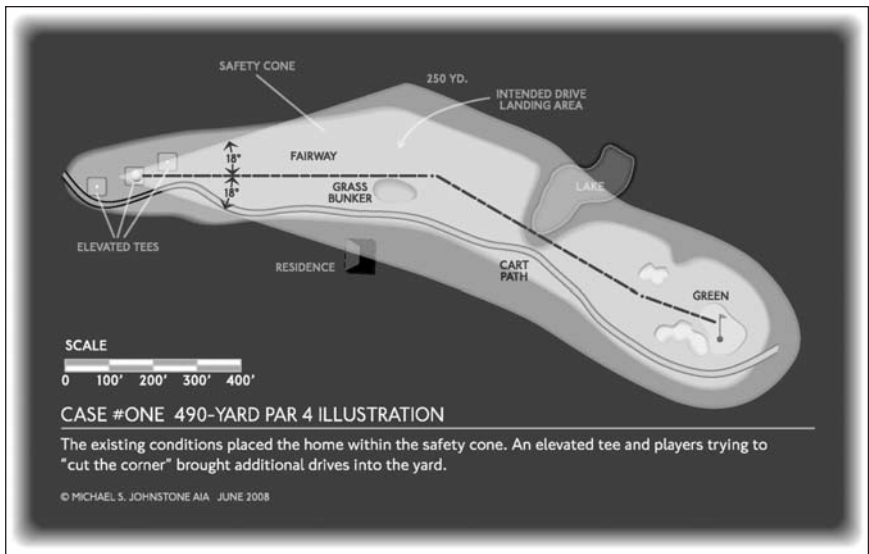
Figure #7.

The home owner retained an attorney and filed suit against the Country Club to cease and desist playing that hole. The author was retained directly by the home owner as a golf course design consultant. The author visited the site, documented the existing conditions and plotted the probable flight of a high percentage of tee shots. The house sat at ground zero for slicing flight of right handed players teeing off from an elevated tee. The author took the owners statement about his experiences, obtained scaled aerial photos, and reviewed photos of the damage. After a discussion with the original Golf Course Designer, he stated that he had heard about the problem at this home and mentioned that they had much less intrusion when the grove of substantial trees that he had placed in front of this home had been blown down during the storms Ivan and Francis!

As a result of the author's analysis the following changes were proposed and documented for the hole:

1. Re-orient the tee boxes to aim toward the intended landing area to the left side of the fairway.
2. Place a target pole in the center of the intended landing area.
3. Replace the trees that had been blown down in previous hurricanes.

4. Place a tall hedge to the right of each tee to channel drives to the left.
5. The owner should add a “natural grasses” garden at the rear of his property to create an area which makes the retrieval of out of bounds shots very difficult.

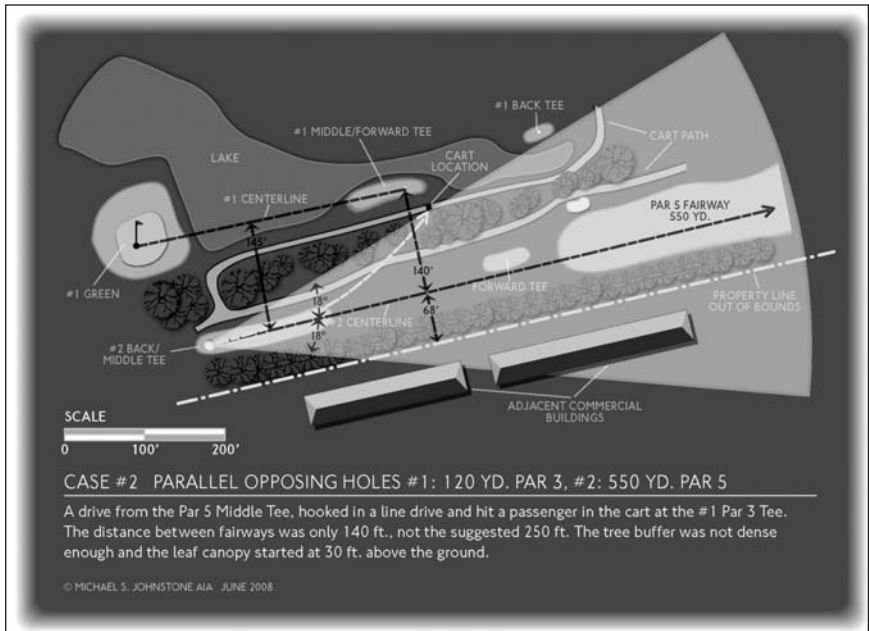
Figure #8.

The tee on the #1 Par 3, where the accident occurred, was located parallel to the #2 Par 5 that played in the opposing direction with the tee only 160 feet from the accident scene. The center line of the #1 Par 3 Fairway was only 140 feet from the #2 Par 5 center line and well within the Safety Envelope. Trees that formed a partial buffer between the two fairways were mature, widely spaced and the leaf canopy began at about 30 feet from the ground. There was no other protection, such as additional lower vegetation, shrubbery or safety screens and no warning signs at either tee.

1. The playing circumstances, angle of flight and proximity of the tees indicated that the line drive golf ball shot that struck the plaintiff, came from the #2 Par 5 tee.
2. The #1 tee, where the plaintiff was struck, was well within the Safety Envelope and therefore the accident was foreseeable.

3. The center lines of the two fairways were only 140 feet apart, which is less than the generally accepted 250 feet.
4. The sparse tree buffer, lack of additional vegetation or screening and the lack of any warning signs contributed to the likelihood of this accident occurring.

In an attempt to provide a long Par 5 hole the Golf Course Designer shoe-horned the fairway along the exterior property line violating the Safety Envelope on both sides of the fairway and creating a hazardous condition for golfers on the #1 Par 3 Tee and the adjacent commercial properties.
